# **DUSTON** CONSERVATION AREA

# CONSERVATION AREA APPRAISAL & MANAGEMENT PLAN

Planning Policy & Conservation Section Northampton Borough Council October 2009

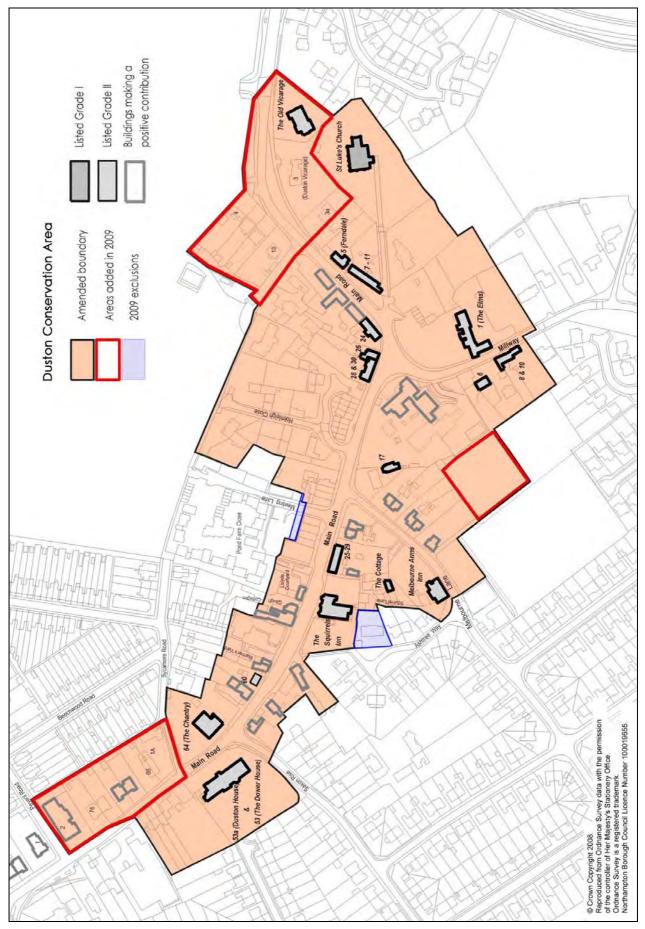
Conservation area showing listed buildings, local list candidates and boundary changes

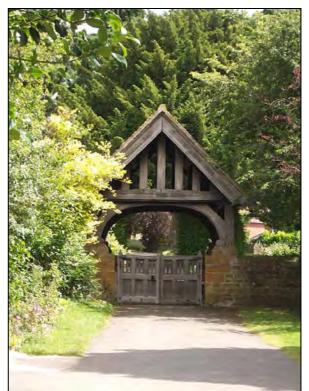
Lych Gate

St Luke's Church is the oldest surviving and the most architecturally significant building within the conservation area. It stands in a secluded spot at the end of a long lane in a large churchyard (4500m<sup>2</sup> approx). Parts of this building date from the 12<sup>th</sup> century, with the fenestration<sup>3</sup> and tower being added in the 13<sup>th</sup> century. The approach to the church along the lane is characterised by the view through the lych gate<sup>4</sup>.

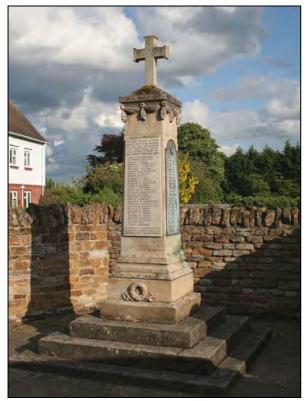
Churchway House is a large white rendered detached dwelling that was built in the mid-1930's and is very representative of that era, with rendered second floor, brick detailing and wide brick chimneys. The war memorial commemorates the Duston residents who died in the First World War 1914-1919. The memorial itself is a limestone pillar solemnly decorated with carved garlands and topped with a crucifix.

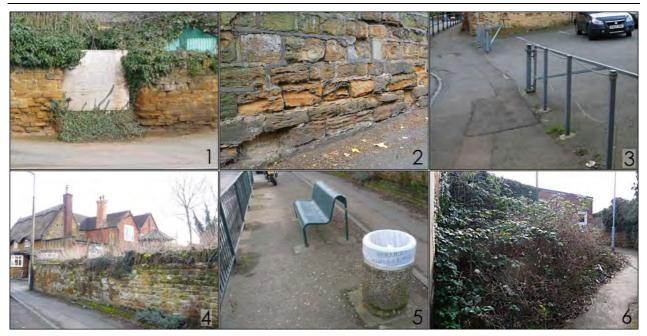
Location	Issue	Action	Term	Respon- sibility
Main Road (corner of Holmleigh Close) (photo 1, p. 26)	Former gateway in stone wall at corner of Holmleigh Close and Main Road has been blocked with plywood. The wall itself is in a poor state of repair (especially the lower courses), and as such would benefit from refurbishment.	Establish who the owner is, and encourage them to make the necessary repairs to the wall.	Short	Site Owner
Main Road, Peveril Road, Sycamore Road, Melbourne Lane (photo 2)	The stone-walls throughout the historic core of the village make a positive contribution to the character of the area and therefore would benefit from a holistic process of assessment and reconditioning.	Encourage owners to make the necessary repairs. This could be supported by Townscape Heritage Initiative funding which could be secured by Northampton Borough Council.	Medium	Respective site owners / Northampton Borough Council.

Main Road (photo 4)	The beer garden of the Squirrels Public House has had some large trees removed from its road frontage. This has increased views into the area and also made the garden a lot lighter, however the loss of key trees on the frontage has had a detrimental impact upon the visual amenity of the conservation area and suitable replacements should be considered.	Discuss the issue with the owners of the Public House.	Short	Site owner.

1- gap in wall near Holmleigh Close2- stone wall near roundabout4 - Squirrels beer garden5 - street furniture near bakeryPhotographs referred to in the Public Realm enhancement table.

3 – Squirrels car park fence 6 – brambles in Squirrel Lane

Location	Issue	Action	Term	Respon- sibility
Main Road	The large raised bed outside the Duston United Reform Church would benefit from having at least one tree planted in it.	Discuss the issue with the Church.	Short	Site owner.
Main Road (photo 5)	The area surrounding the bakery on Main Road would benefit from a comprehensive improvement scheme. Firstly the railings, bin and bench should be replaced with more heritage sensitive types of street furniture. Secondly there is unkempt vegetation including nettles and ivy, which should be removed and replaced with more sensitive plants and possibly a decorative native tree.	This adopted area of highway would be the responsibility of Northamptonshire County Council.	Medium	NCC
Squirrel Lane (photo 6)	Squirrel Lane has a large bush of overgrown brambles, which is unsightly. This should be removed and replaced with more appropriate landscaping, which would have a positive impact upon the amenity of the conservation area.	Discuss the issue with the owners	Medium	Site owners.

Main Road	Main Road suffers from much unnecessary street clutter, in the form of signs, Bus stops and steel railings. The railings impact detrimentally upon the village like character of the Conservation Area. It should be considered whether Duston would benefit form the removal of the railings in front of St Luke's School, and adjacent to the zebra crossing in front of the Bakery. The removal of the barriers could be brought forward in conjunction with a reduction in the speed limit through the centre of Duston.,	Approach NCC to discuss ways to secure a better public realm for the historic core of Duston.	Medium	NBC and NCC
